建築主 五島美術館
所在地 東京都世田谷区玉川上野毛
設計者 吉田五十八設計研究室
施工者 清水建設株式会社
工期 33. 11~35. 4

Location: Tokyo
Architect: Isoya Yoshida
Contractor: Shimizu

五島美術館
Goto Art Museum

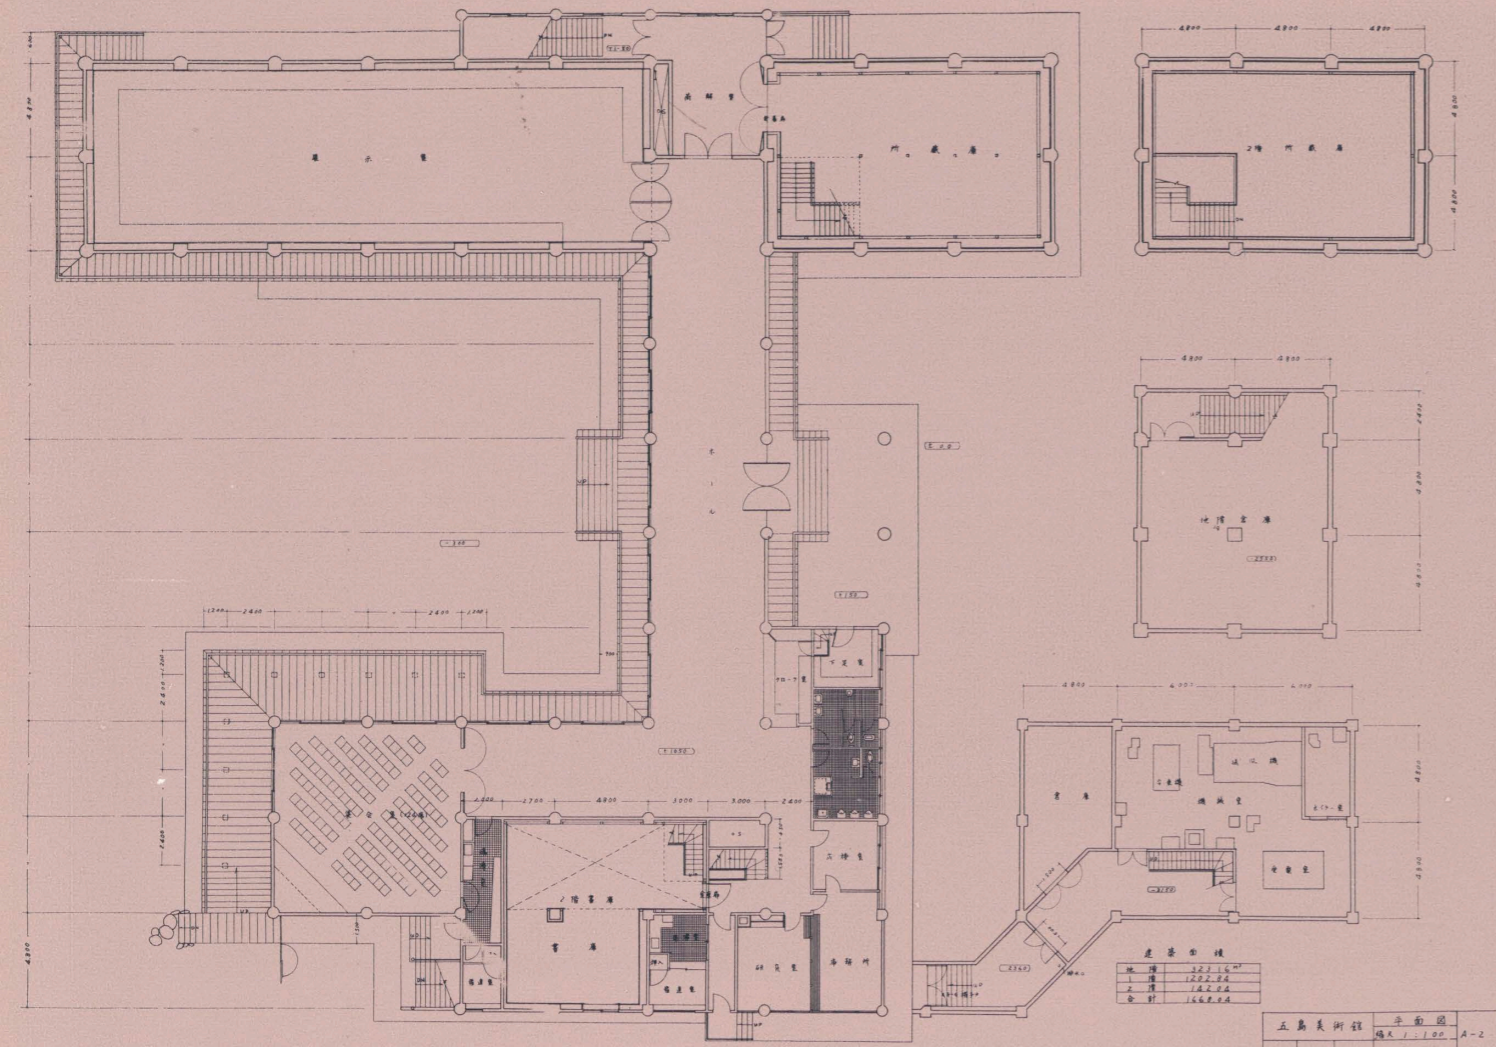
五島美術館平面圖

五島美術館 平面圖
圖號: 1-02 A-2

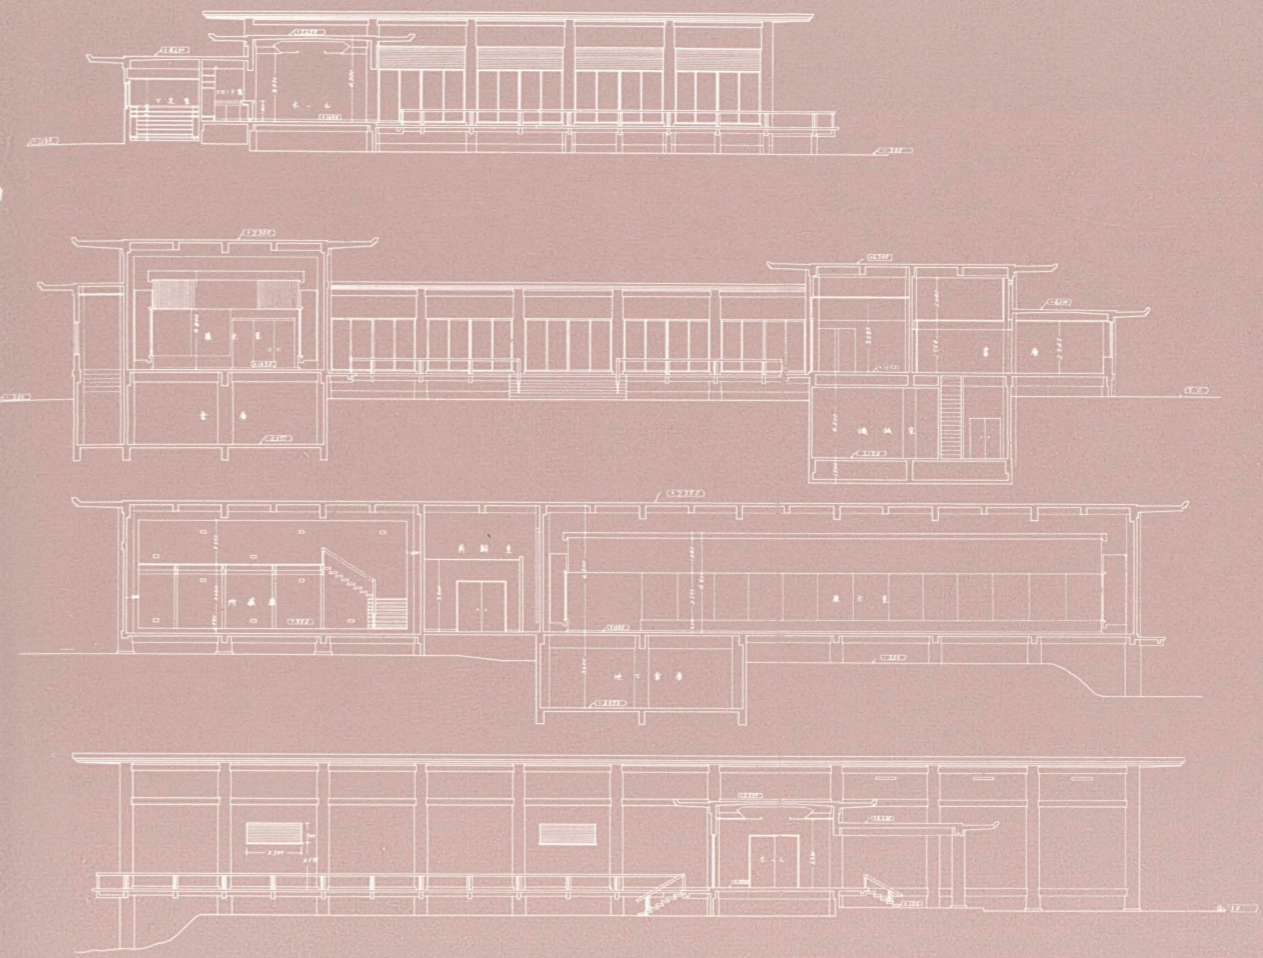
五島美術館 剖面圖
圖號: 1-02
