10 東京都美術館

TOKYO METROPOLITAN ART MUSEUM

REVIEW

Masaya Mukai Sakutaro Okahashi Hiroyuki Iwamoto ●概要

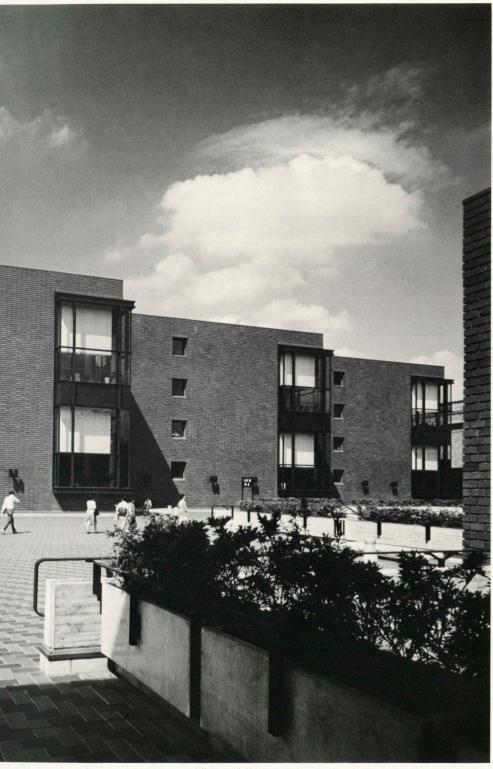
公募展示棟外観/General view of the exhibition wing

外装 炻器質タイルブロック打込み 食堂回り : 耐候性鋼板プレパン処理パネル 広場回り: 手斫り仕上げコンクリート着色ネオパール塗り 内装 公募展示棟 床:プラスチックタイル 壁:軽量鉄骨下地有孔フレキシブルボードVP 天井: ゆ 9 丸鋼100 角格子粉体塗装/企画展示 棟 床:プラスチックタイル 壁:軽量鉄骨下 地プラスターボード染色荒目不燃布張り 天井 : 岩綿吸音板/管理棟・文化活動棟 床:プラ スチックタイル 壁:軽量鉄骨下地ラスボード、 プラスター塗りの上布張りペンキ仕上げ 天井 : 岩綿吸音板および有孔プラスターボードVP 彫塑室・エントランスロビー床: 炻器質タイル 壁:コンクリート手斫り仕上げ着色ネオパール 塗り 天井:砂岩打込み小叩き仕上げPC板

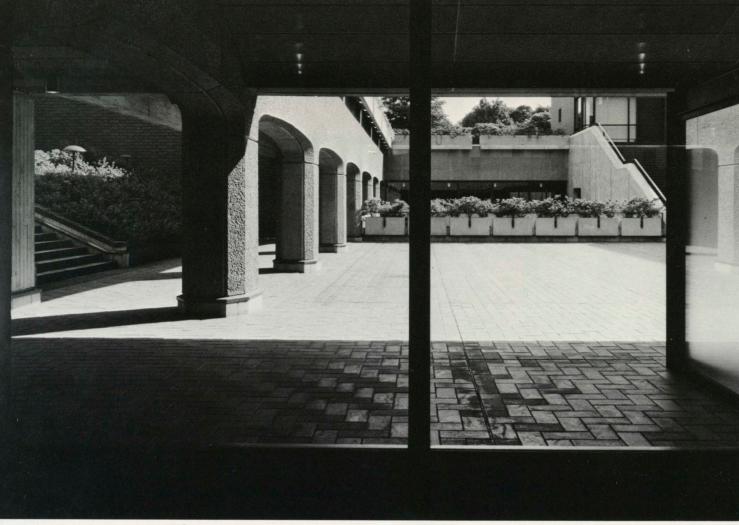
エントランスロビーからみた広場/Plaza seen from the entrance lobby

る困難な問題を生むことになったのは当然で、特に地下部分にある収蔵庫や展示室における湿気防止のための技術的処理などそのゆうなるものだが、一方この建物は、その重厚な壁面仕上げの源をなす独特の打込みタイルの施工や、広場まわりのゆるい弧状をなすアーケードの三次曲面のハツリ仕上げである上、それへの微妙な着色の苦心など、数々の施工上の難問をすぐれた創意工夫でのり切り、まれに見る空間効果を創りあげるのに成功している。

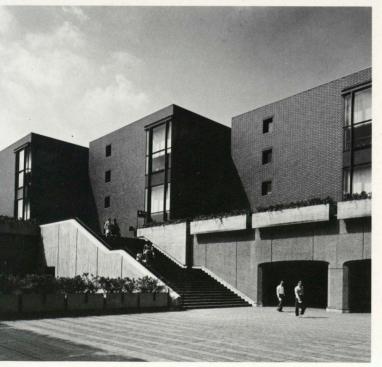
エントランス前からみた公募展示棟/ Exhibition wing seen from the entrance

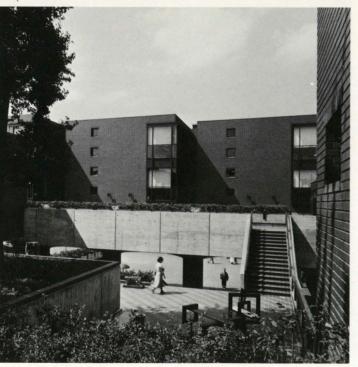
広場ごしにみた公募展示棟/ Exhibition wing seen from the plaza

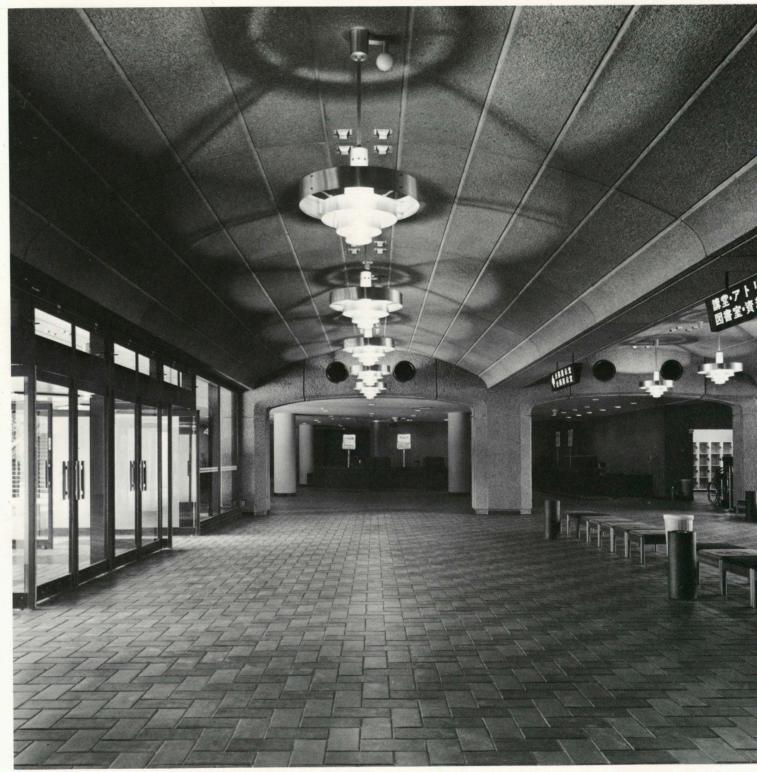
エントランスロビー/Entrance lobby
