所在地 福井市文京 3-16

建築主 福井県

設計者 (株)佐藤武夫設計事務所

竣工 昭和52年9月

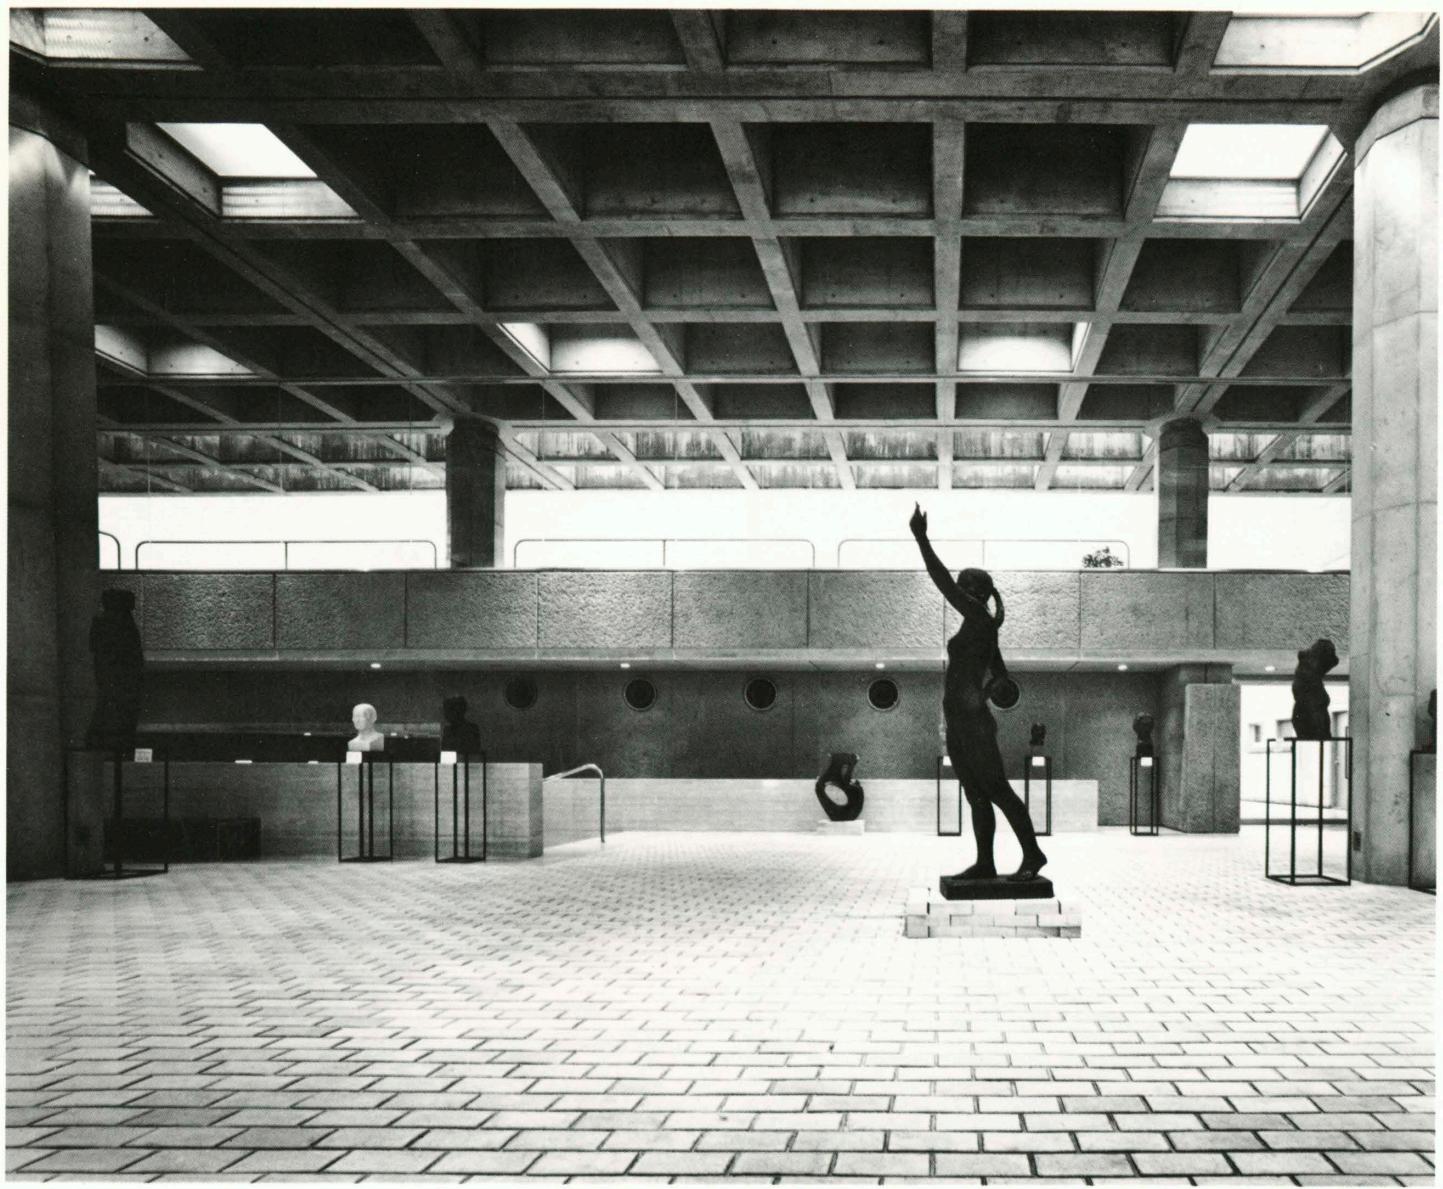
エントランスロビー。 Entrance lobby.

内装 エントランスロビー 床：磁器質タイル貼り 壁：コンクリート打放し化粧仕上げ、ブッシュハンマー仕上げ、ばっ水剤刷毛引き 天井：コンクリート打放し化粧仕上げ格子梁／企画展示室 床：ホモジニアスピニール床タイル 壁：ビニールクロス貼り 天井：アルミ押出し型材、アクリル系樹脂焼付ルーバー／収蔵庫 床：木下地⑦18 mmナラフローリング張り素地仕上げ 壁：木下地⑦18 mm杉フローリング張り素地仕上げ 天井：野縁⑦18 mm杉フローリング張り素地仕上げ

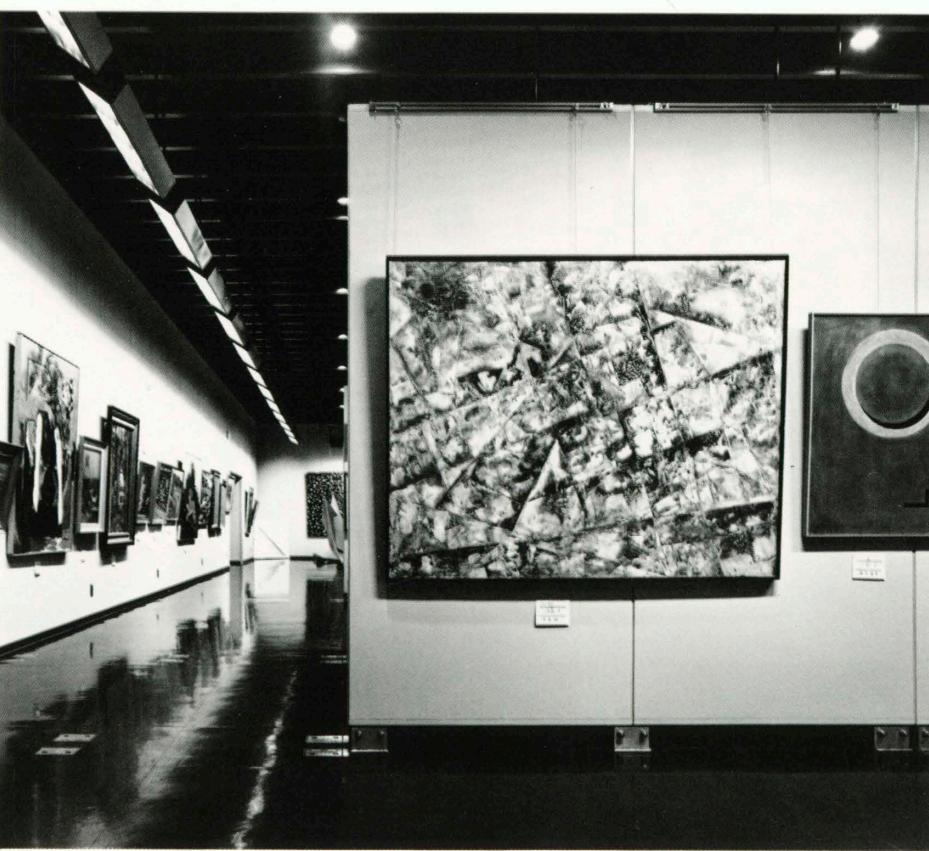
企画展示室。 Exhibition hall.

展示のシステムについては、随時展示壁面を加減する方法を開発したり、省エネルギーの観点もあって、自然採光と人工照明を合理的に組み合わせて設備計画を行なうなど、多様化する現代美術に柔軟に対応している。
