桂離宮御殿

KATSURA DETACHED PALACE

所在地 ———— 京都府京都市西京区桂御園
 建築主 ———— 宮内庁京都事務所
 設計者 ———— 宮内庁京都事務所
 施工者 ———— 株式会社 大林組
 竣工 ———— 1982年3月25日
 location ———— Kyoto City
 owner ———— Imperial Household Agency, Kyoto Office
 architects ———— Imperial Household Agency, Kyoto Office
 contractor ———— Ohbayashi-Gumi, Ltd.
 completion date ———— March 25, 1982

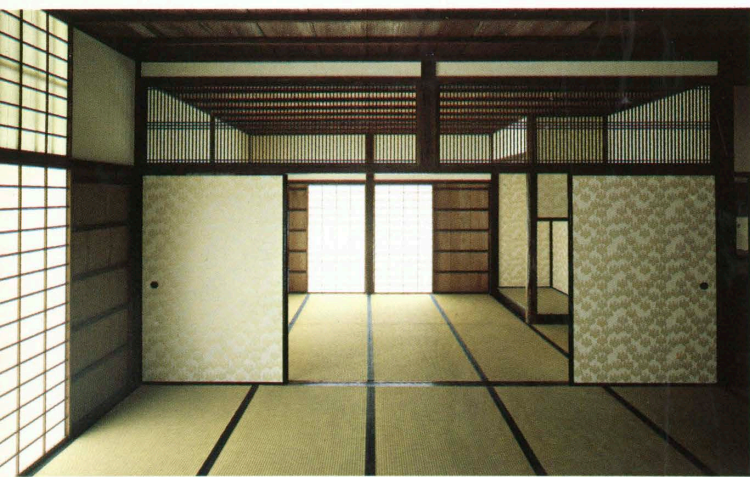
古書院二の間～一の間／View of the old-shoin's room-one from room-two

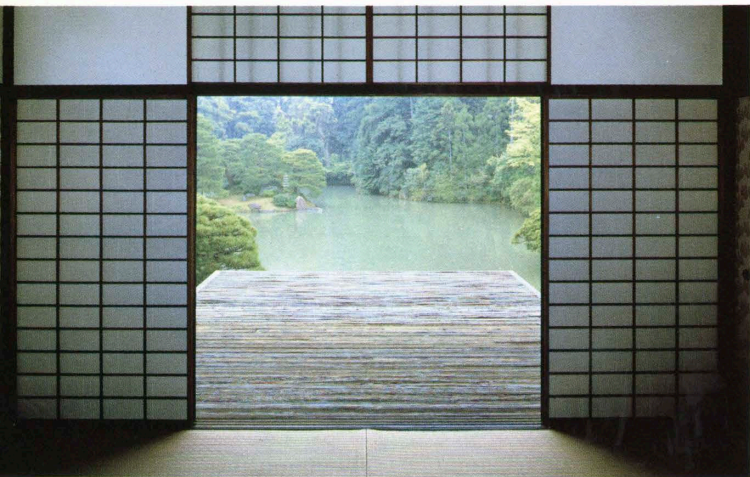
古書院月見台／Moon-viewing platform of the old-shoin

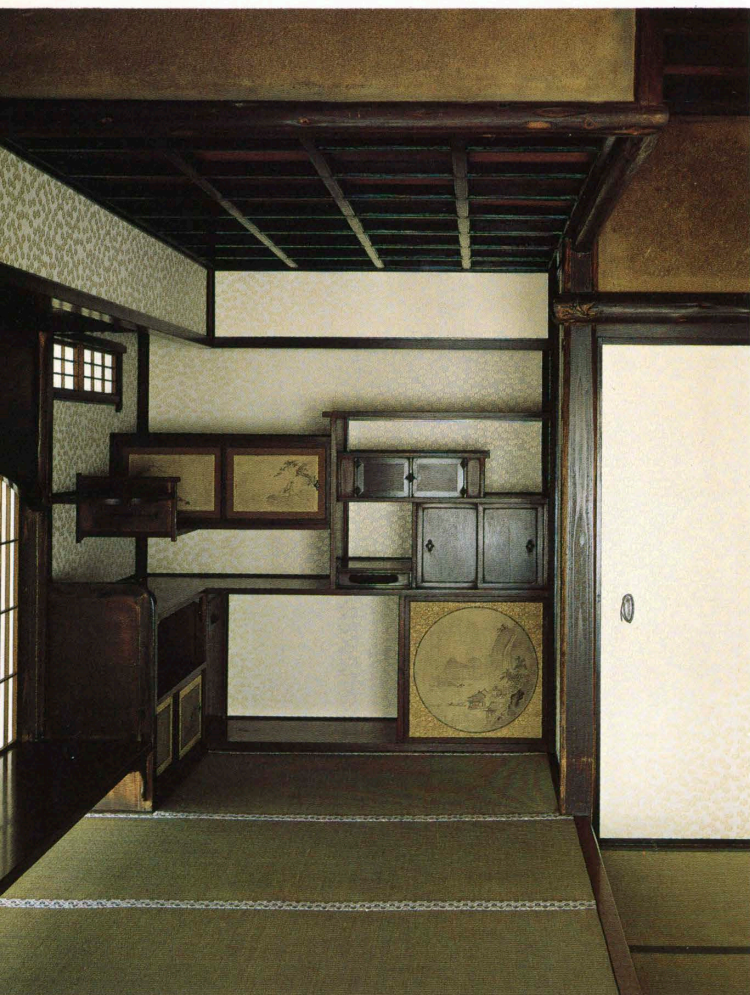
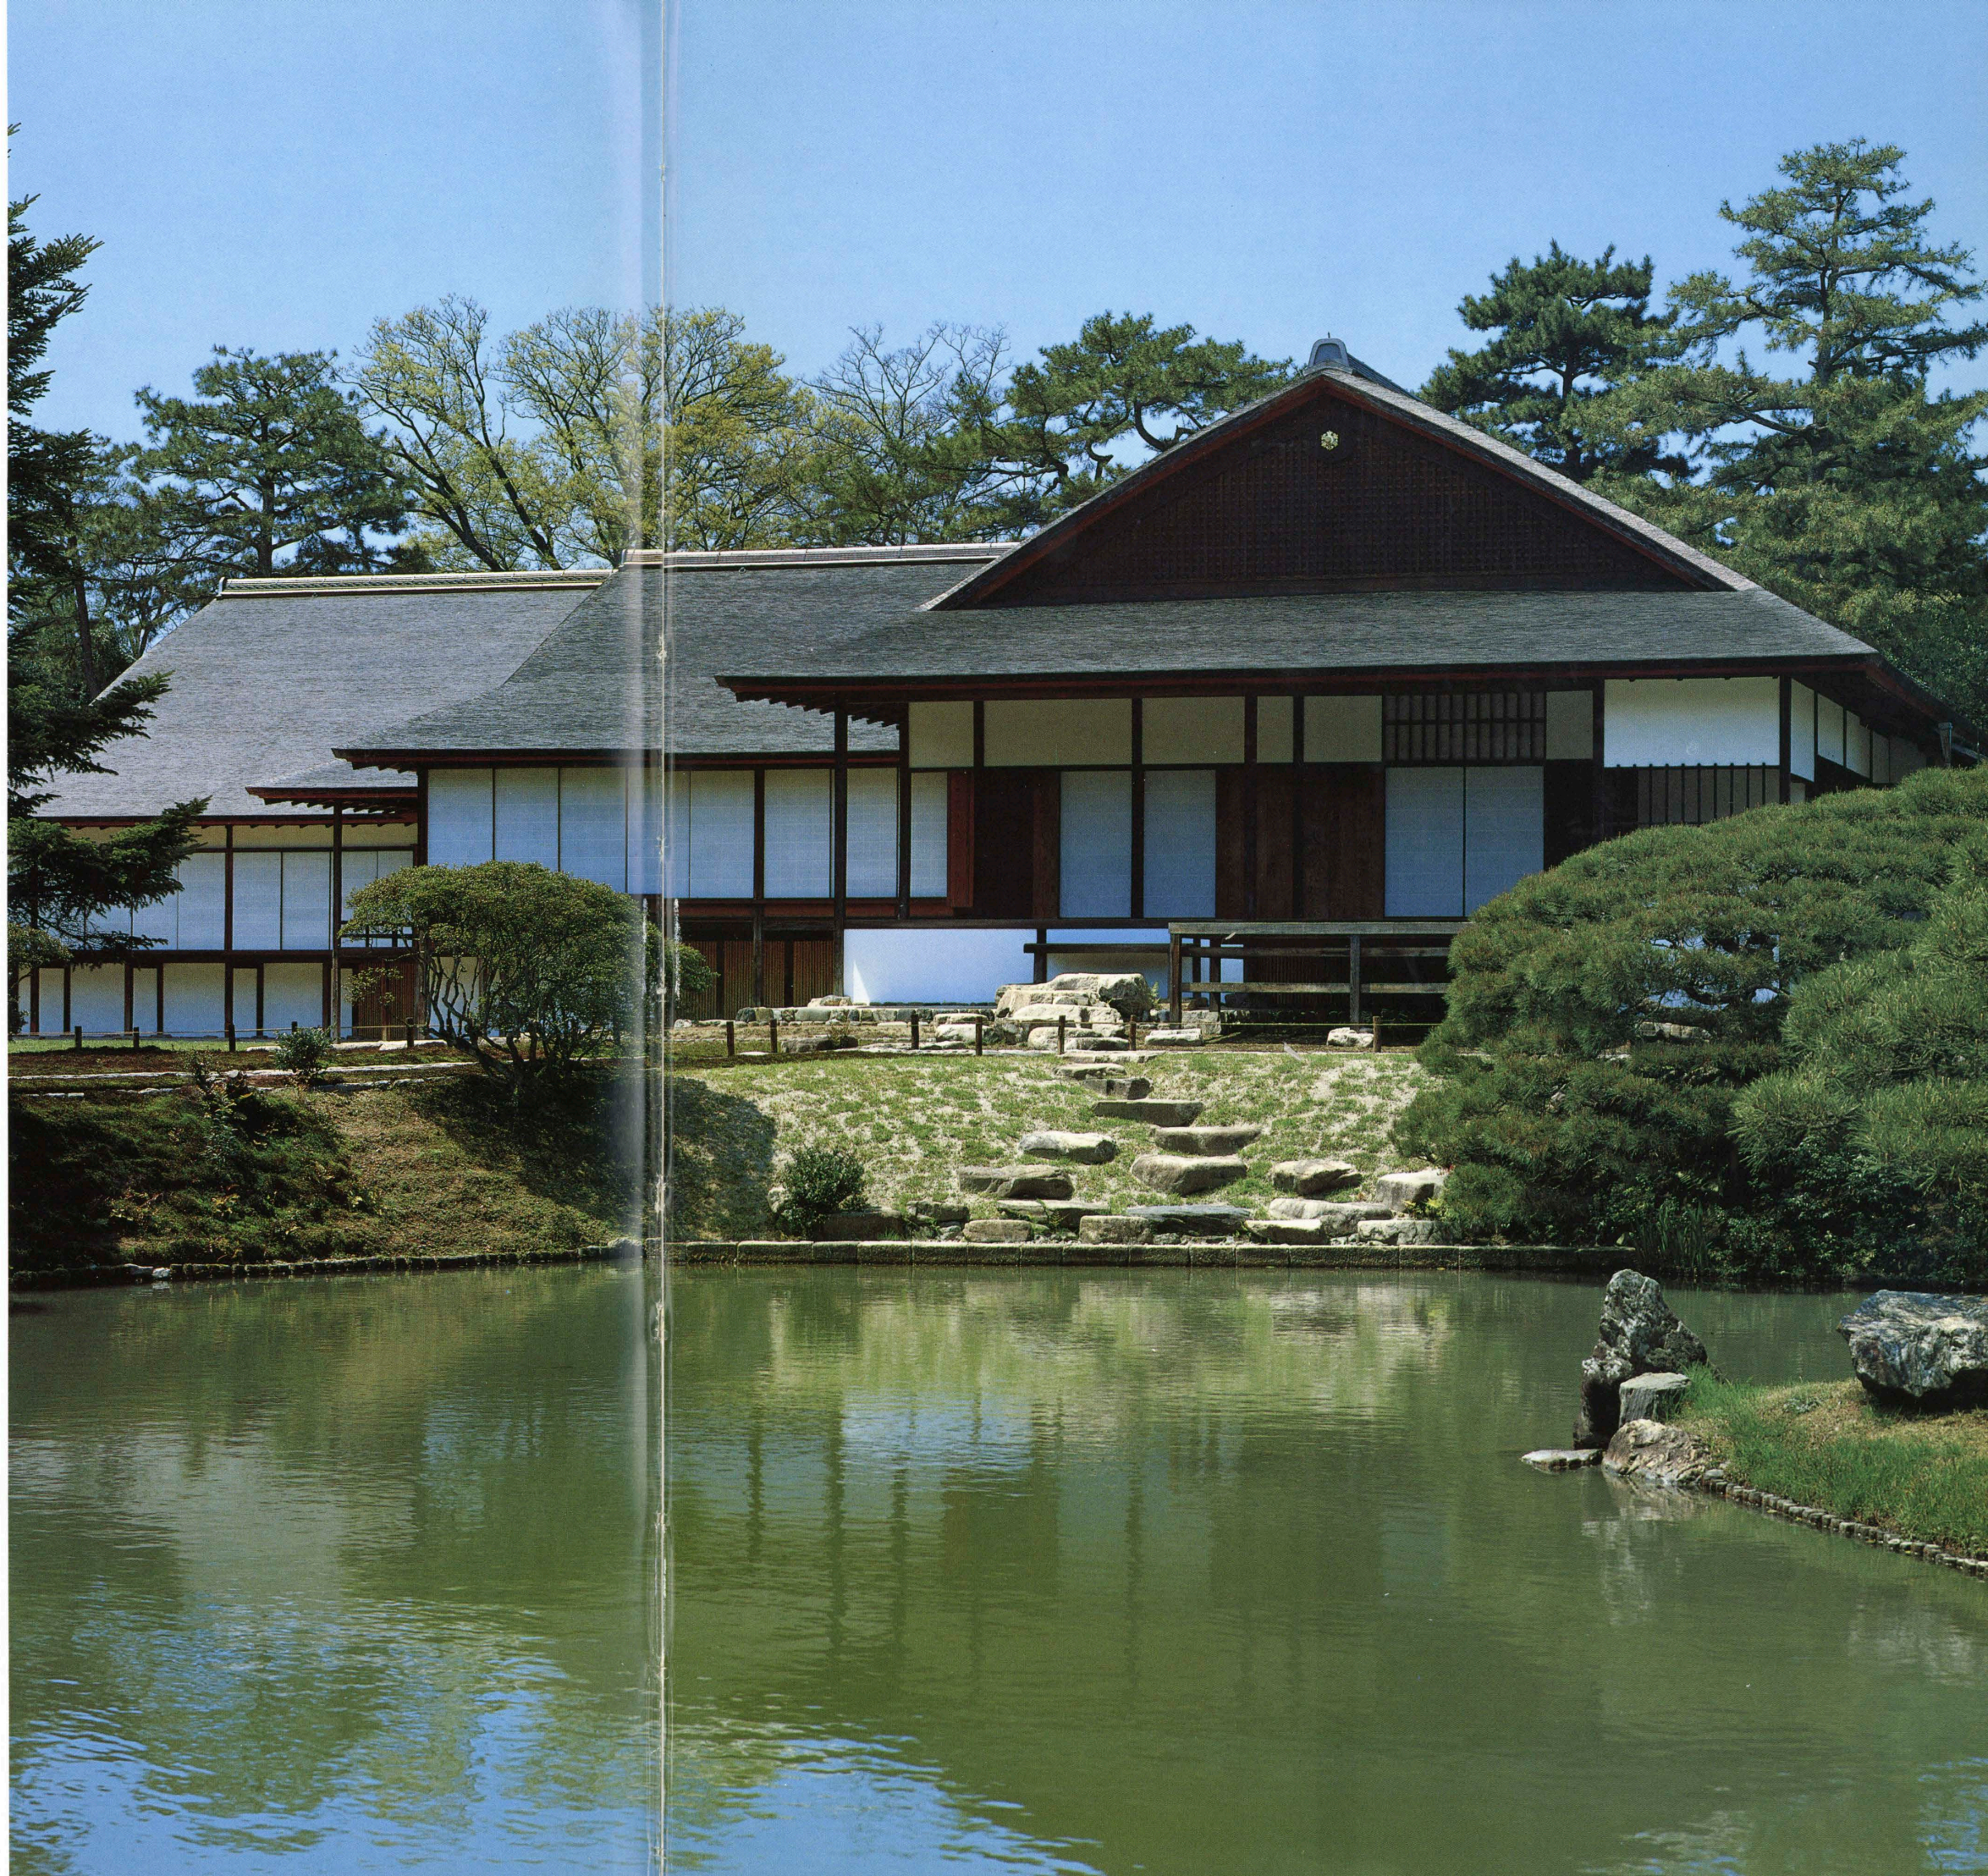
新御殿柱棚／Katsura-shelves of the new-palace 右：全景／right: General view
