日蓮正宗総本山大石寺六壺

NICHIREN SHOSHU HEAD TEMPLE TAISEKI-JI MUTSUBO

施工者/清水建設株式会社 竣 工/1988年9月30日 Location/Fujinomiya City, Shizuoka Prefecture
Owner/Nichiren Shoshu Head Temple Taiseki-Ji
Architect/Shimizu Corporation
Contractor/Shimizu Corporation
Completion Date/September, 1988

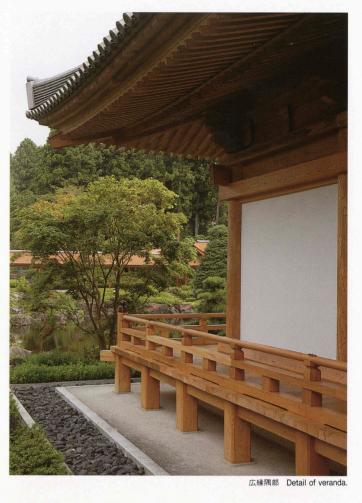
正面 Facade.

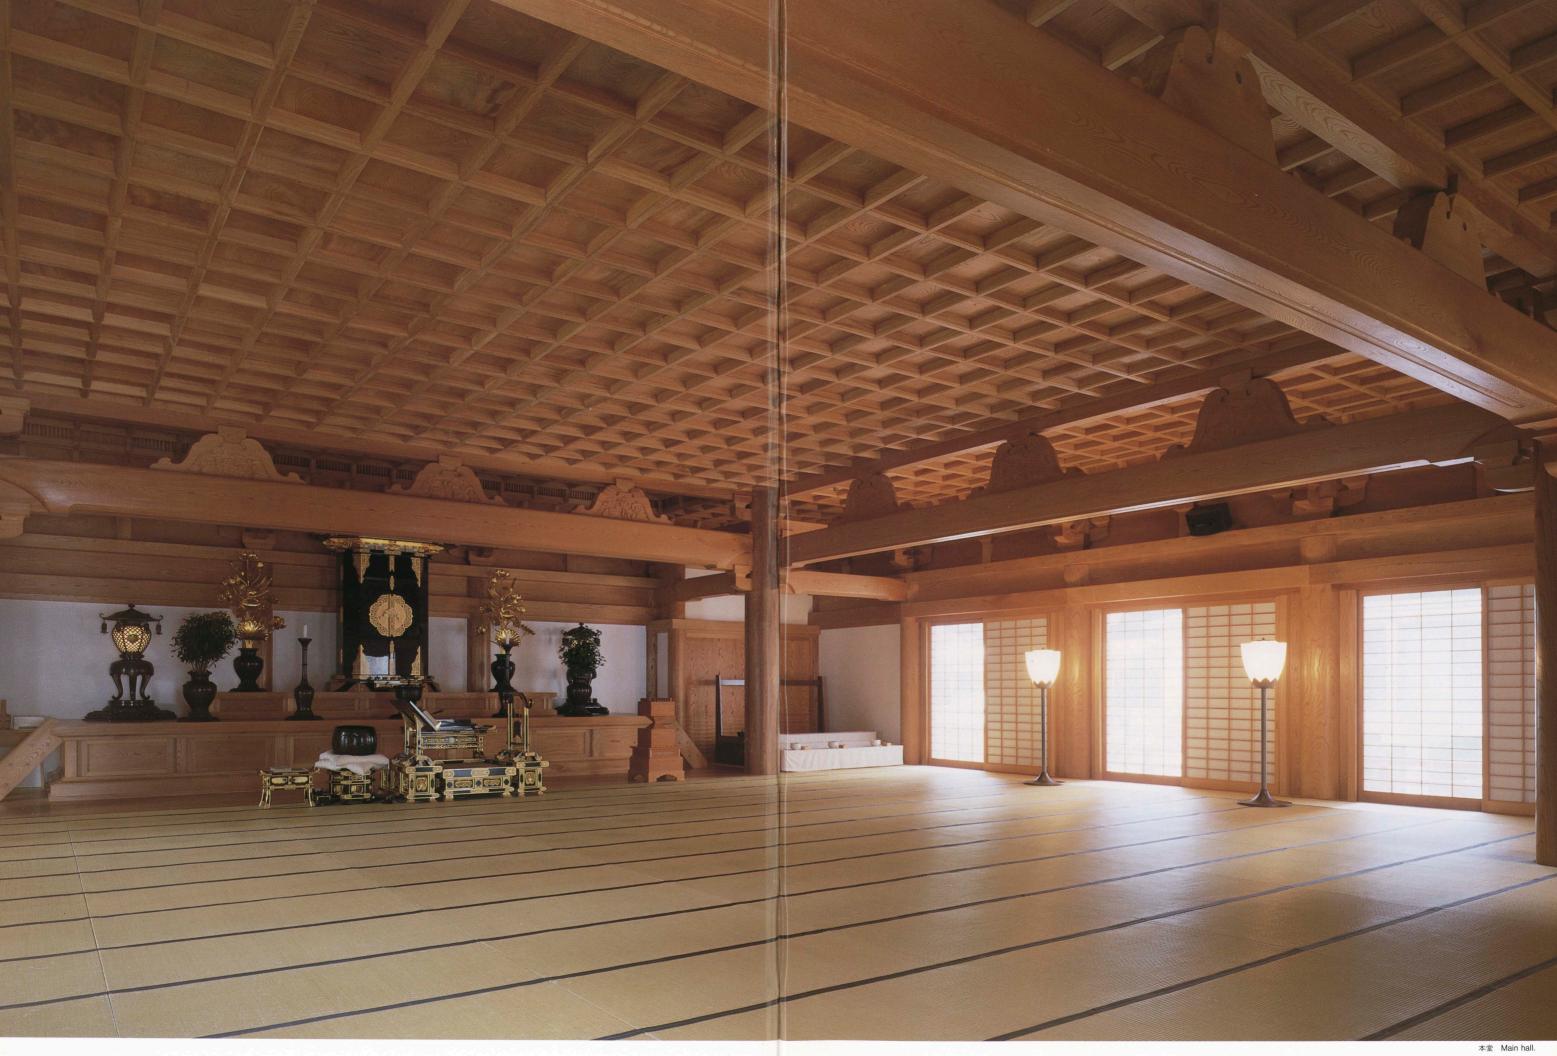
The interior of the hall (10 bays or about 18m to a side) is a single large space supported by only 4 posts. In Japan, in some traditional buildings, certain parts of the floors and ceilings of rooms like this one are raised to symbolize the exalted social position of the personages for whom these special zones are intended. To eliminate all consideration rank, in the Mutsubo, the floor level is uniform throughout, as is the ceiling height. The number of supporting posts is less than half what would normally be reguired in a room of this size. Creating a framework strong enough to support the load demanded very strong joints and connections. To ensure safety in time of earthquake, actual-size tests were carried out.

10間(約18m)四方のお堂の内部は柱4本の大空間になっており、天井、床とも高低差のない空間となっている。これは座る位置によって、上下差が生じないための配慮であり、そのために柱の数を出来るかぎり少なくすることがその要因となっている。古来の同規模の建築物と比較して柱数が半数以下という架構を行うために強固な継手、仕口の工夫や耐震性の実大実験を通して、この大架構の実現が果たされた。
